Impacts of Soil Degradation: Case Study in Bogawantalawa South Grama Niladhari Division, Nuwara Eliya District, Sri Lanka

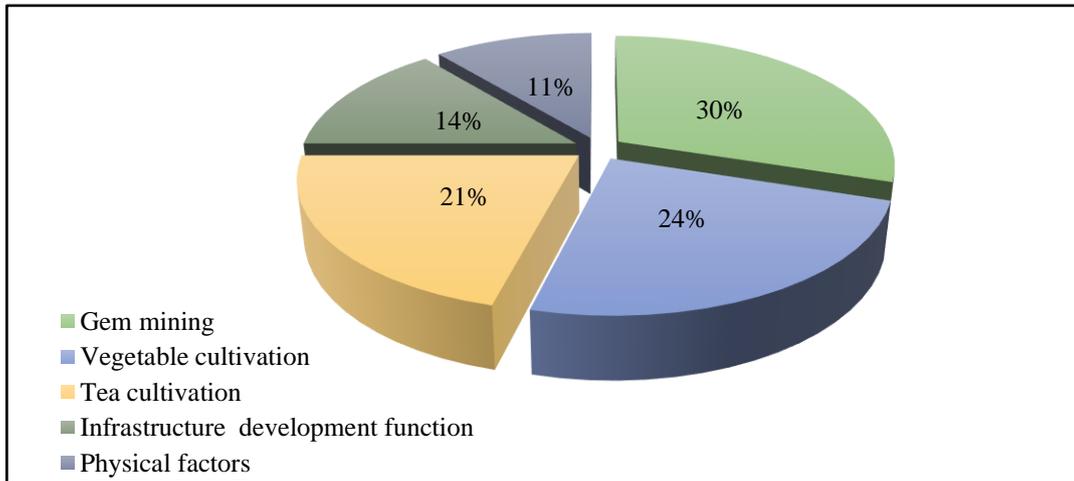
Figure -2: Major causes for soil degradation in the study area

According to the result of this study, approximately 30% of the gem mining activities attributes 52% of the soil degradation in the study area. The gem mining process, with the approval of National Gem and Jewelry Authority of Sri Lanka, has been taken place close to the Kesalgamuwa river basin (Chaplton-Bridwell). However, this legal gem mining process has also not been carried out, following the laid down guidelines and standards and there are no productive follow-up or management system to secure the safety of the soil layer of the area. Its unsystematic digging and refilling process, and lack of maintenance of the extracted soil provide evidences for validating this statement true.

Further the second prime cause for this recurring issue is vegetable cultivation (24%), with the usage of chemicals, pesticides and fertilizers, irregular irrigation method (supply water by a garden hose and watering cans) and mono-cropping (carrot, potato and beetroot) *etc.* Accumulation of all these activities attributed for 47% land degradation of the study area.

Similarly, 21% of tea cultivation in the study area has also contributed for the soil degradation in the long-term. This study observed that the many previously tea planted land plots have been abandoned, due the illegal gem mining activity. According to the Dharmasena, (2014), “Soil erosion is very high on abandoned and poorly managed tea lands in the upcountry”. This reveals that the Government and non-government organizations have ore concerns about the soil quality of tea land. Hence, this factor has a minimum contribution to the soil degradation (55%) of the study area.

In addition, the increasing trend of infrastructure developments function (14%) has become a reason for soil compaction, soil erosion and landslide in the area. In 2014, approximately 163,260 (sq.ft) of new land were used for constructing new buildings in Nuwara Eliya district (Department of Census and Statistics, 2015). Indian housing project (Own land –Own village) has contributed for soil degradation at a percentage of 34%.

The research findings indicate that the 11% of physical factors have been contributing to soil degradation in the study area. Table-1 illustrates the annual average rainfalls in the Nuwara Eliya District and excessive rainfall damages the topsoil layer and causes the soil erosions subsequently. Especially, deep valley and steep slope spread in Nuwara Eliya district accelerates the high volume of soil degradation. Both of these physical factors are interrelated to landslide and flood and 80 families in the Amabagamuwa divisional secretariat divisions were affected, due to the landslides and flooding in the year 2018 (Amabagamuwa Divisional Secretariat Division, 2018).

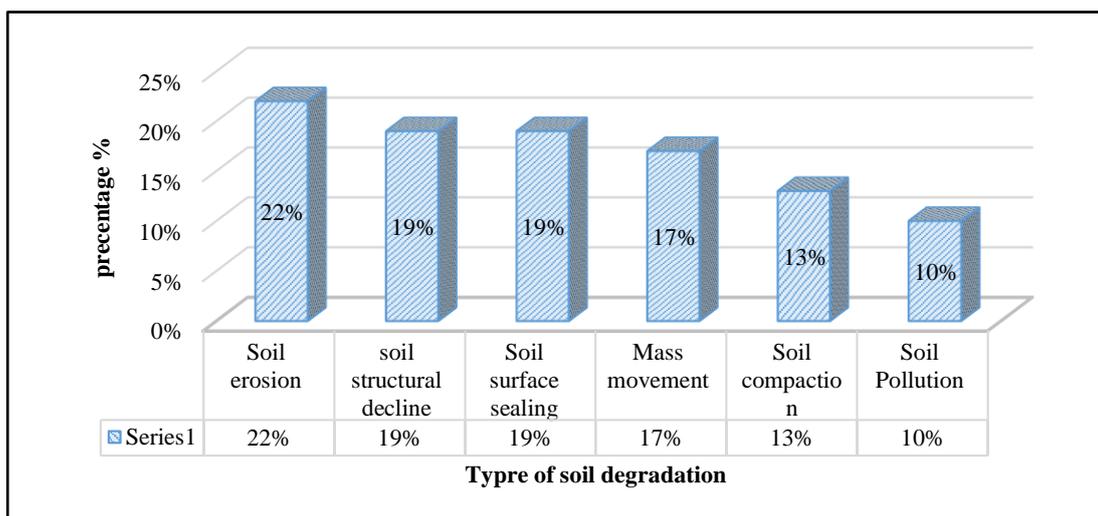
Figure-3: Types of soil degradation in the study area

Below figure-3 shows the major types of soil degradation in the study area. The soil erosion (22%), soil structural decline (19%), soil surface sealing (19%), mass movement (17%), soil compaction (13%) and soil pollution (10%) are major types of soil degradation that this study has found. The soil erosion has been frequently occurred in the gem mining land spots, vegetable and tea cultivated lands, due to the water flows in the area. Further, soil structural decline and soil sealing increase the soil degradation level, especially in the infrastructure developing area, such as Indian housing project (Own land-Own village) and rural road developments, exists in the study area.

Mass movement of land in the irregular tea growing slopes and gem mining pits, is an unfavorable soil degradation's type, damages residential property and environment of the area. The frequent such process induces the soil compaction, which could be seen footpaths, concrete road, playground and residential areas in Bogawantalawa-south GND. Soil pollution is mainly caused by residents.
