# Impacts of Soil Degradation: Case Study in Bogawantalawa South Grama Niladhari Division, Nuwara Eliya District, Sri Lanka

<sup>1</sup>M.Krishnasoban, <sup>2</sup>Dr. Fareena Ruzaik

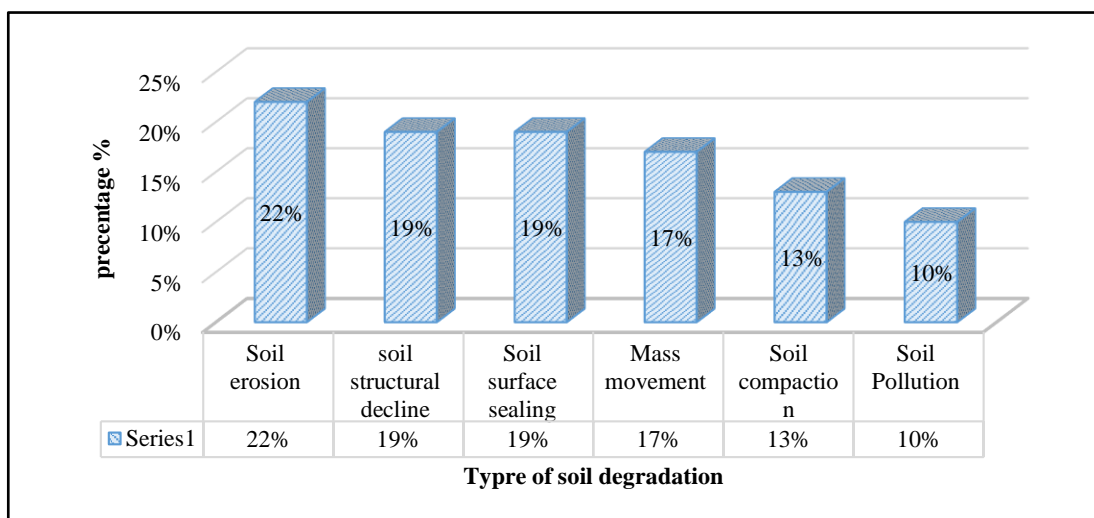
**Figure-3: Types of soil degradation in the study area**

Below figure-3 shows the major types of soil degradation in the study area. The soil erosion (22%), soil structural decline (19%), soil surface sealing (19%), mass movement (17%), soil compaction (13%) and soil pollution (10%) are major types of soil degradation that this study has found. The soil erosion has been frequently occurred in the gem mining land spots, vegetable and tea cultivated lands, due to the water flows in the area. Further, soil structural decline and soil sealing increase the soil degradation level, especially in the infrastructure developing area, such as Indian housing project (Own land-Own village) and rural road developments, exists in the study area.

Mass movement of land in the irregular tea growing slopes and gem mining pits, is an unfavorable soil degradation's type, damages residential property and environment of the area. The frequent such process induces the soil compaction, which could be seen footpaths, concrete road, playground and residential areas in Bogawantalawa-south GND. Soil pollution is mainly caused by residents.
